ENGINEERING INVESTIGATION OF FAILURES OF CABLE USED TO TOW THE TDU-32A BANNER TARGET FROM T2C AIRCRAFT

by Brent Meeker

6 DEC 2000

**NAVAL AIR WARFARE CENTER, WEAPONS DIVISION
CODE 531100E**

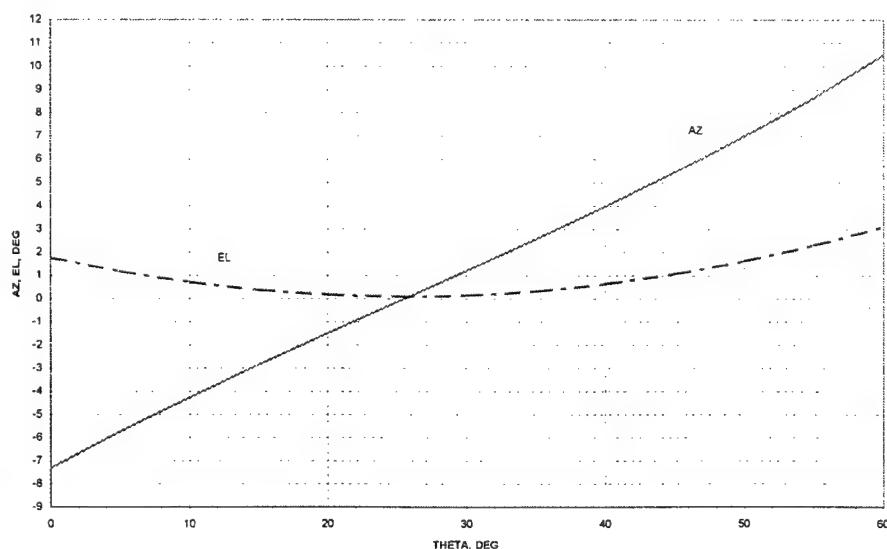
AZ AND EL OF EXHAUST POINT vs ROLL ANGLE, THETA

Looking from the rear, Theta 0 of the left engine is $\text{ATAN}(20/42) = 25.5$ deg. Assuming the exhaust point is 42 in below and 20 in to the left of the roll rotation axis of the A/C and the coordinates of the rotation point are $X=0, Y=0$, the following plot can be made:

The above plot assumes the tow point to be 0.4 ft below the exhaust point in level flight at zero alpha.
 By incorporating the effect of alpha with roll at different airspeeds, the following results:

By inspection of the chart above, it appears the use of Theta's of 30 and 60 deg are not representative of the potential critical points for coincidence of the cable with the lower left exhaust point. It is recommended that the study be expanded about a roll angle of 25 deg. Also, the entire speed range needs to be explored more thoroughly. Improvements in the approximations of airspeed, weight, and geometry must also be made.

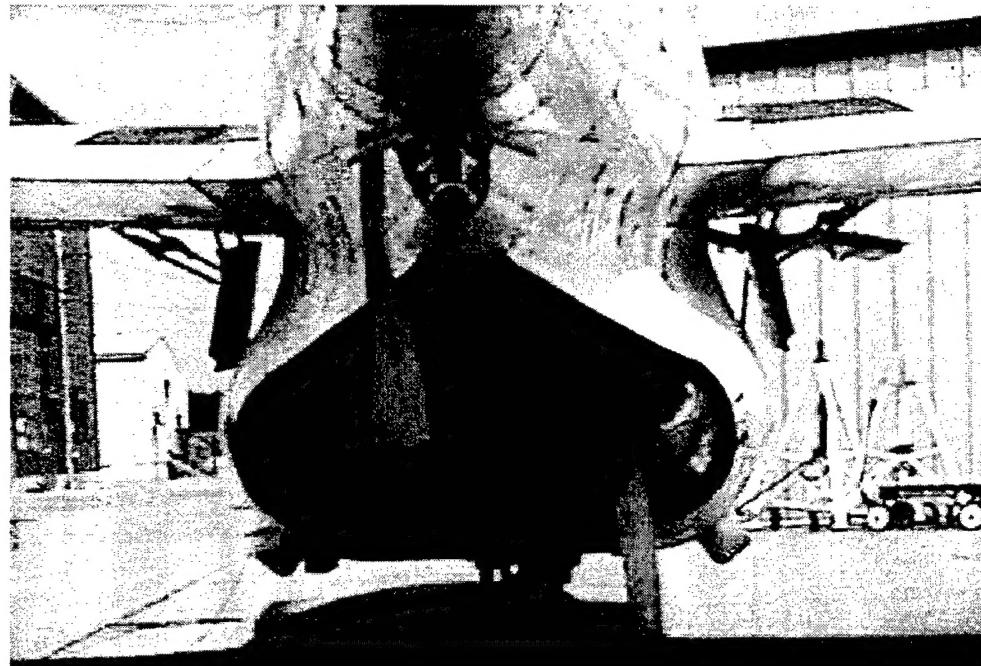
The T2C has twin engines mounted low on the fuselage as shown in figure 1. The engines are approximately 2.2ft apart, center-to-center. Each exhaust has a diameter of approximately 1.1ft.

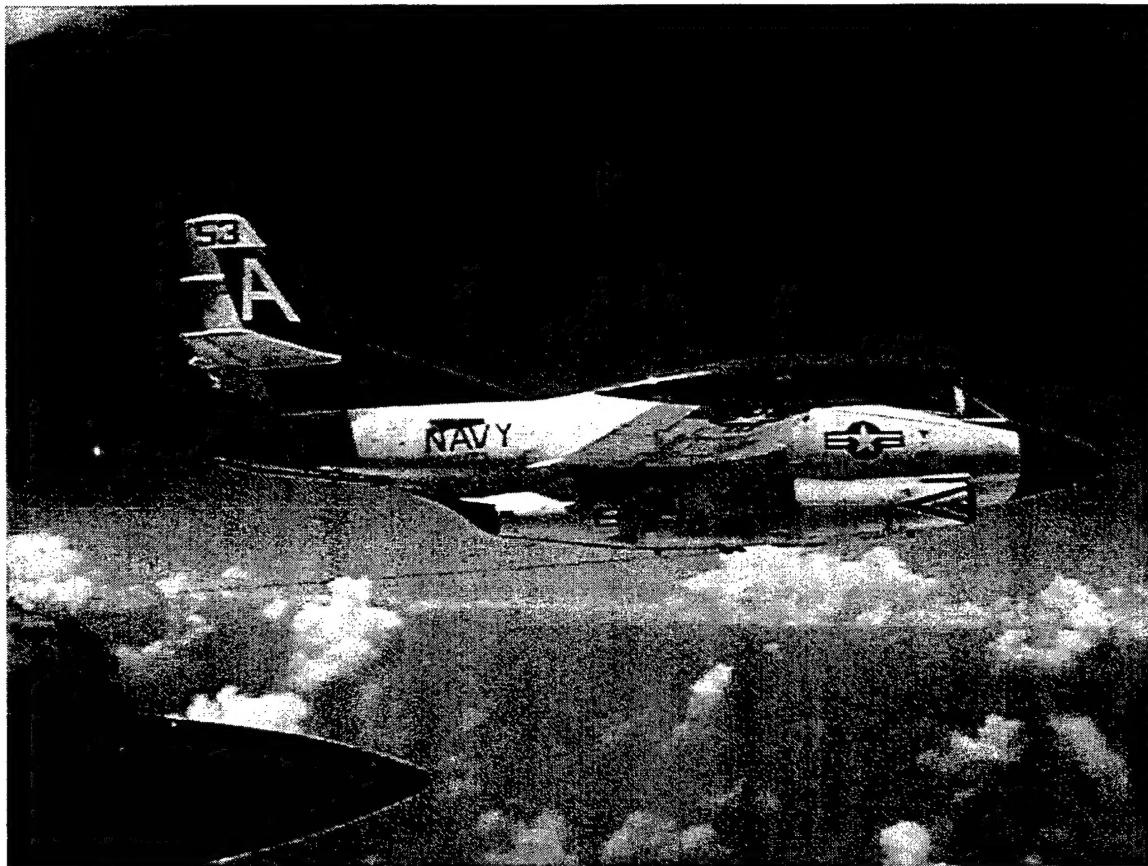
Scaling from figure 2, the tow point is 13.3ft forward of the exhaust on the center-line of the belly. This photograph was taken a 200KEAS in straight and level flight. At this flight condition, the bottom of the exhaust opening is seen to be 0.58ft above the tow point.
